Reference: Existing Unsafe Conditions and Recommendation Regarding Dudleyville Pond Dam (MA00512), Unnamed Tributary to Sawmill River, Town of Shutesbury, Massachusetts

Attachment A – Photo Log

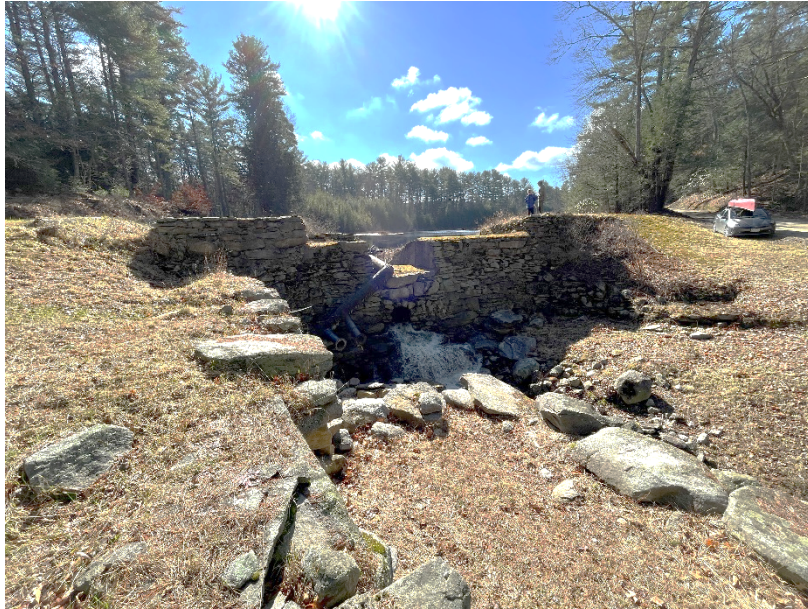
Photo 1. Overview of the dam facing upstream from the downstream right upper masonry wall

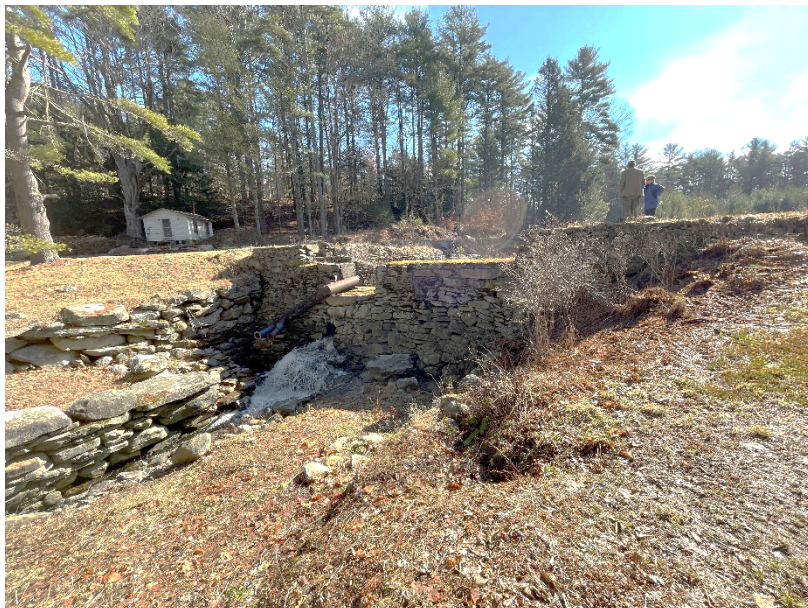
Photo 2. Overview of the dam facing upstream from the downstream left upper masonry wall

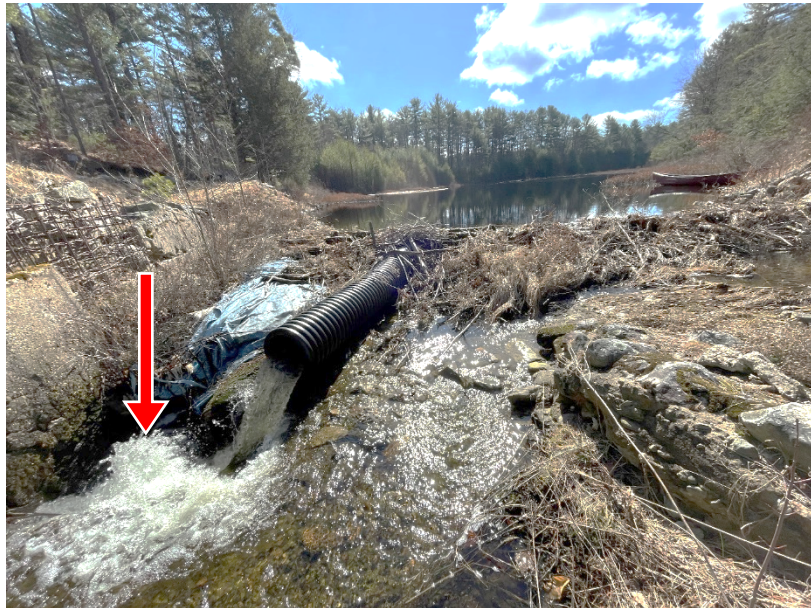
Dudleyville Pond Dam is Structurally Deficient and in Unsafe condition. During the 2024 site visits, Stantec observed conditions that were similar to those reported in the 2022 Phase I I/E Report. In addition, a large, well-developed beaver dam is located immediately upstream of the dam and is currently impounding water at levels above the primary spillway crest. Flow is currently being conveyed through a “beaver-deceiver” conduit through the beaver dam and into a hole on the upstream side of the dam spillway that discharges flow through the low-level outlet pipe.

Photo 3. Overview of the beaver dam from the dam primary spillway facing upstream; note where the beaver deceiver outlet discharges into the low-level outlet pipe

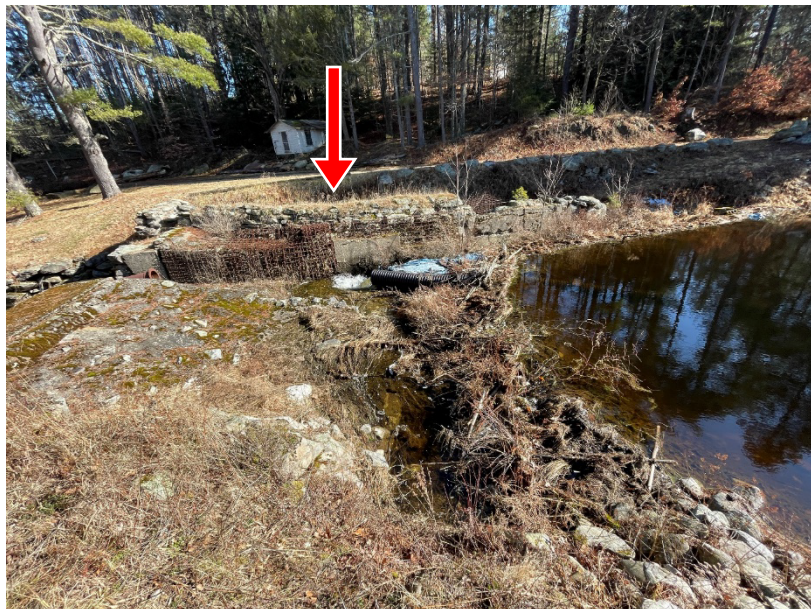
Photo 4. Overview of the dam spillway and beaver dam from the left spillway abutment; note location of void space behind the right dam wall

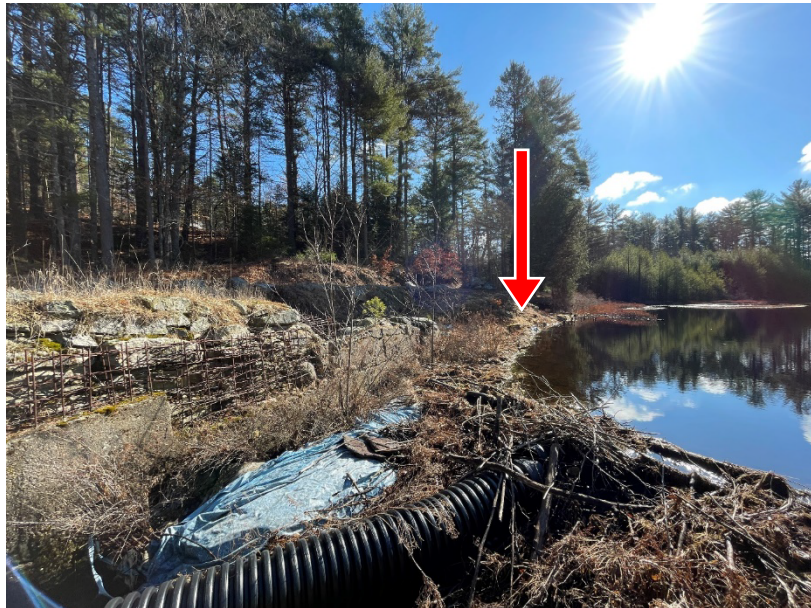
In addition, review of available information and records as well as observations made during the site visits suggest that this location has a historically high-level of beaver activity and ongoing beaver activity appears to be problematic and challenging to manage along this reach of the river. Due to the dam’s condition, ODS has ordered that the impoundment be maintained in a drained condition through use of the low-level outlet. The existing beaver dam observed at the dam is currently impounding water above the normal pool spillway elevation with it threatening to overtop and spill into a large void that was excavated between the right dam stone-masonry wall and the adjacent driveway. A high-flow event may result in overtopping at this location which could accelerate dam failure and failure of the downstream culvert.

Photo 5. Overview of the beaver dam from the spillway upstream end of the spillway facing; note location of potential overtopping during high flow conditions into the excavated void space

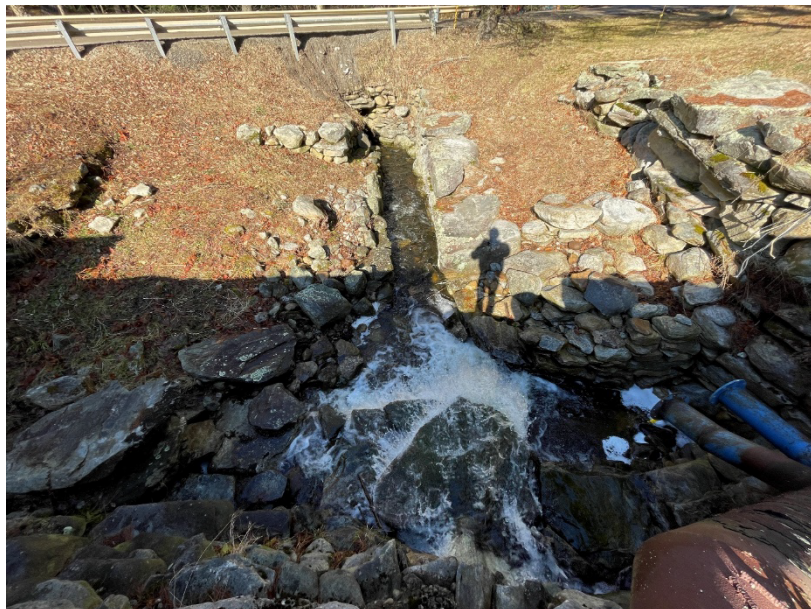
Discharge through the low-level outlet pipe is conveyed downstream from the dam through an approximately 4-ft-wide stone masonry channel for approximately 40 ft before reaching a 2.5-ft span by 5-ft tall stone masonry culvert under Montague Road. This culvert appears to be undersized based on measurements in the field of the downstream channel as well as observations made at upstream and downstream infrastructure. Upstream from the residual dam impoundment, there is a 4-ft-diameter culvert that conveys approximately 40% of the drainage area of the dam. Downstream of the dam on Richard Dudley Road, which has no substantial additional drainage contributions compared to the dam location, there is an approximately 7.5-ft-span bridge and a 4-ft-diameter culvert side-by-side. Due to the configuration of the Montague Road culvert immediately downstream from the dam, it is our opinion that this structure would have limited conveyance capacity if occluded with material (e.g., woody material, dam rubble). Occlusion of the culvert would likely occur with failure of the dam during a high-flow event, which would increase the likelihood of subsequent failure of the culvert. Therefore, although the existing structure appears to be undersized, removal of the dam to eliminate the risk of dam failure during a high-flow event would be expected to substantially reduce the likelihood of subsequent failure of the downstream Montague Road culvert.

Photo 6. Overview of the downstream channel and downstream Montague Road culvert facing downstream from the spillway

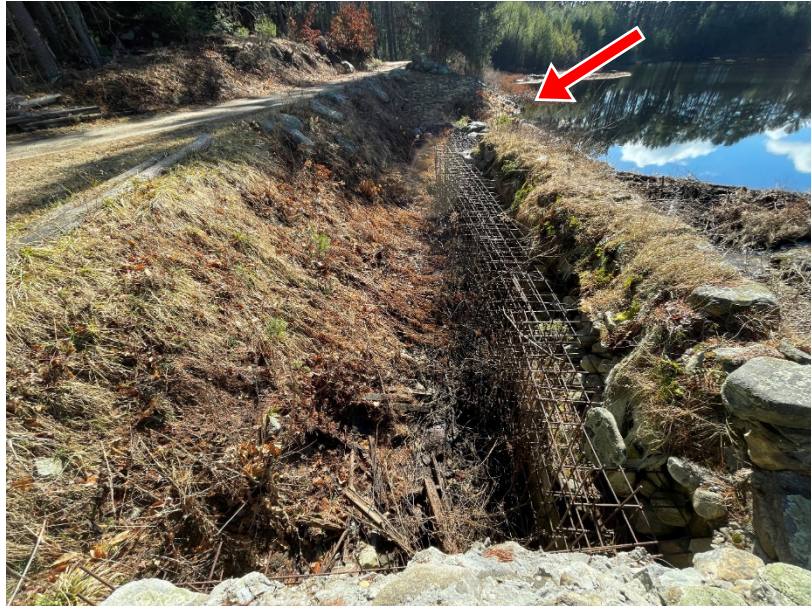
Photo 7. Overview of the excavated void space behind the right dam wall facing upstream; note location of potential overtopping during high flow conditions into the excavated void space

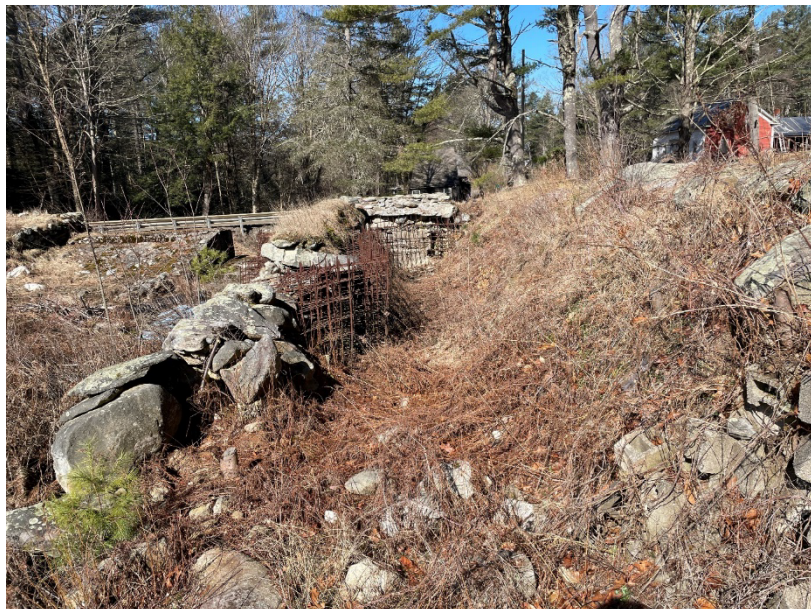
Photo 8. Overview of the excavated void space behind the right dam wall facing downstream
