Special Permit Site Visit Report

Site: Nextera Energy, Inc. ground-mount solar energy facility, 130 Pratt Corner Road, Shutesbury, MA (permitted as the Wheelock Solar Project).

Purpose: Inspection and assessment of compliance with Special Permits PB-SP-6/5/15 and PB-SP-19.02.

Date and Time: August 8, 2024, 10:30am to 12:30pm.

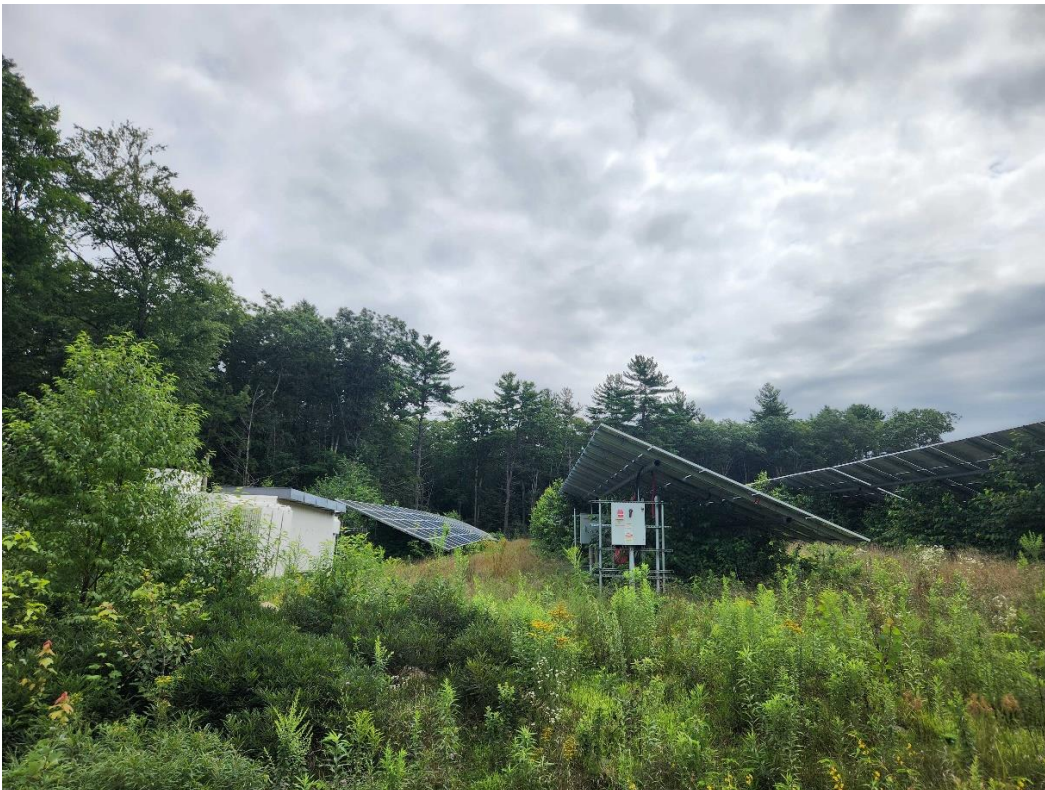
Dense herbaceous vegetation covered the ground around and between the rows of solar arrays (Special Permit Operation Conditions, Item 11). Woody vegetation was growing below many arrays and in places up through gaps between individual solar panels. Walker reported the company mows between and around the arrays in the fall and that no herbicides have been used at the site (Special Permit Operation Conditions, Item 8). He explained that the company's priority is to keep vegetation cut back where it limits access to equipment, but stated that it is difficult to use mowers directly below the arrays because of the type of racking system used. He stated that shading effects from the protruding vegetation caused 1 to 2 percent loss of panel efficiency but was not a significant concern.

Location 3 (looking east). Herbaceous ground cover surrounding the solar arrays and electrical equipment.

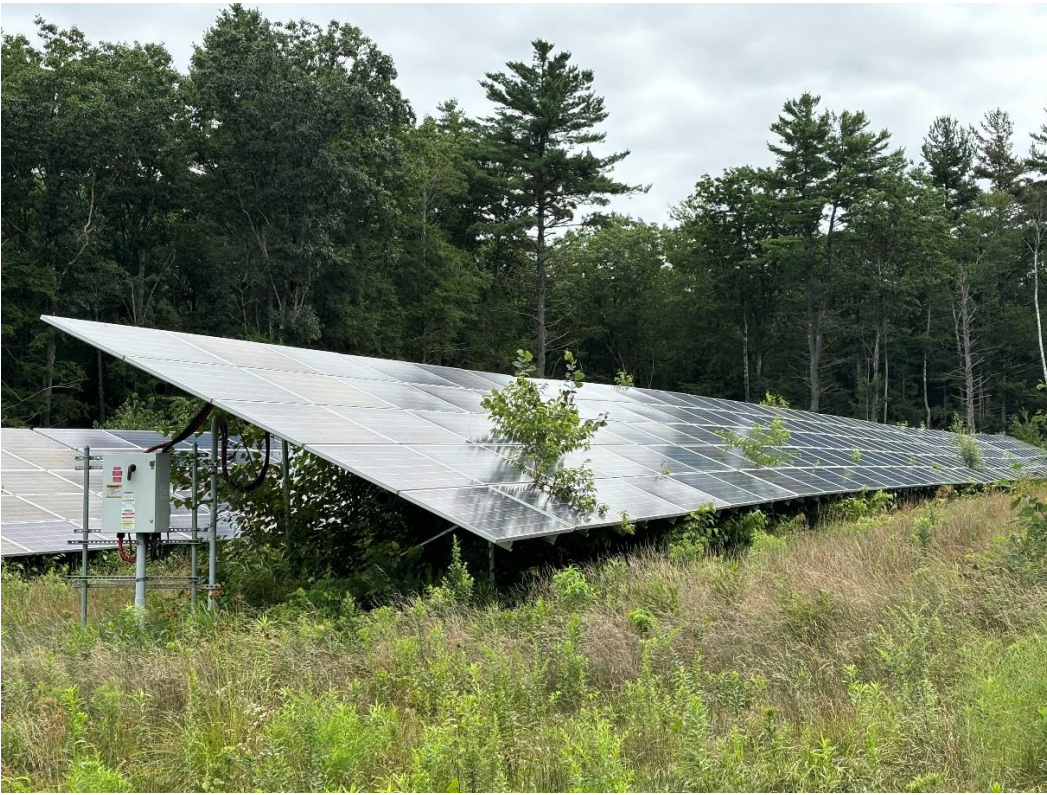
Location 3 (looking east). Herbaceous ground cover and woody vegetation growing up between solar panels.

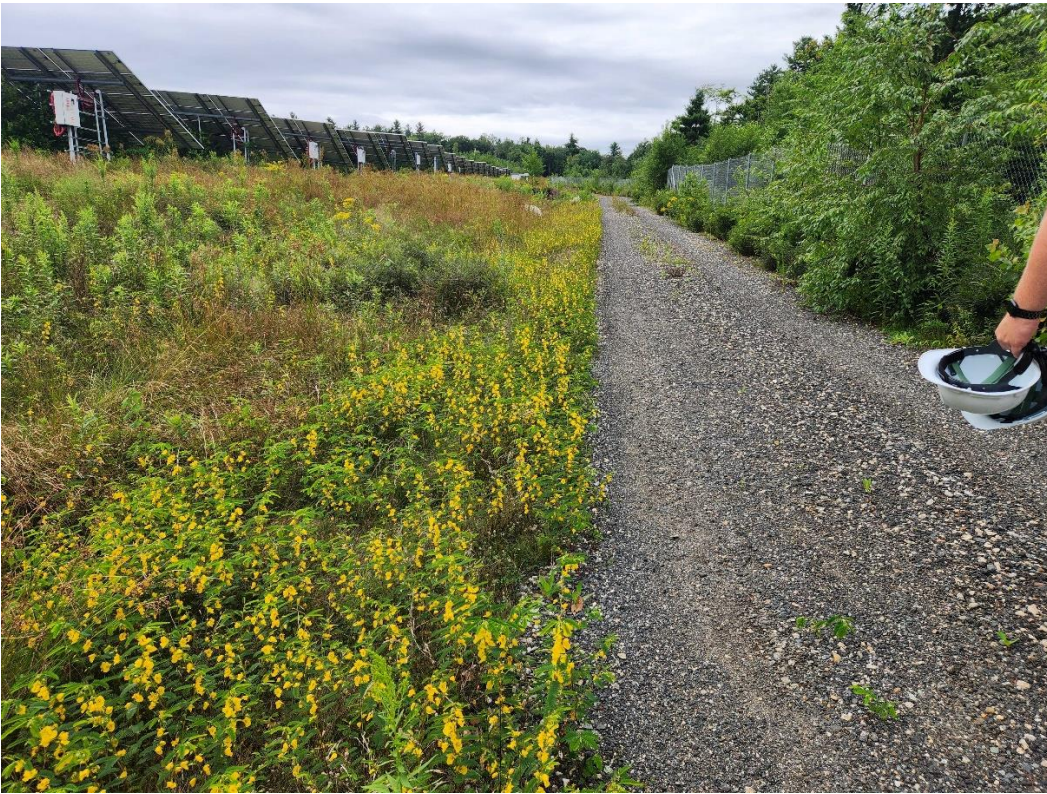
Location 3 (looking south). Service drive, western fence line, herbaceous ground cover, and western edge of arrays.

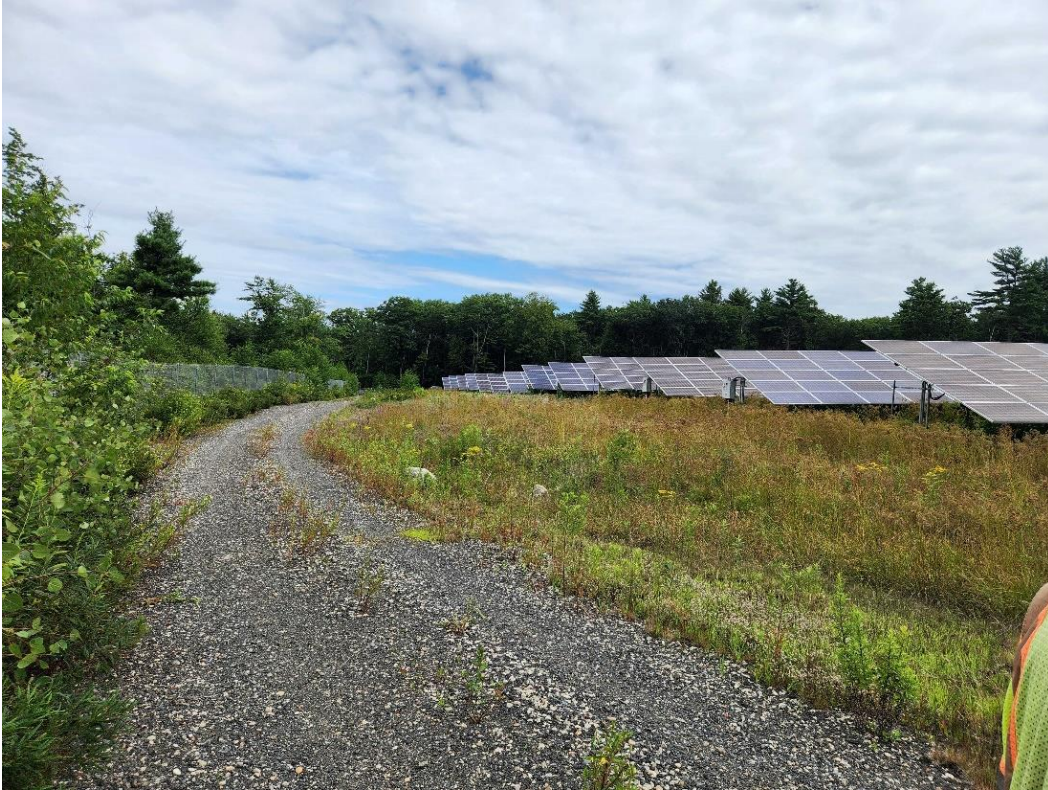
Significant vegetation was growing along the perimeter fencing at the western edge of the facility (Special Permit Operation Conditions, Item 12). The western stormwater detention pond was observed from the gravel service drive. It was vegetated and no standing water was apparent.

Location 4 (looking north). Service drive, western fence line, herbaceous ground cover, and western edge of arrays. The western stormwater detention pond (not visible) is located on the opposite side of the fence (left side of the photo).

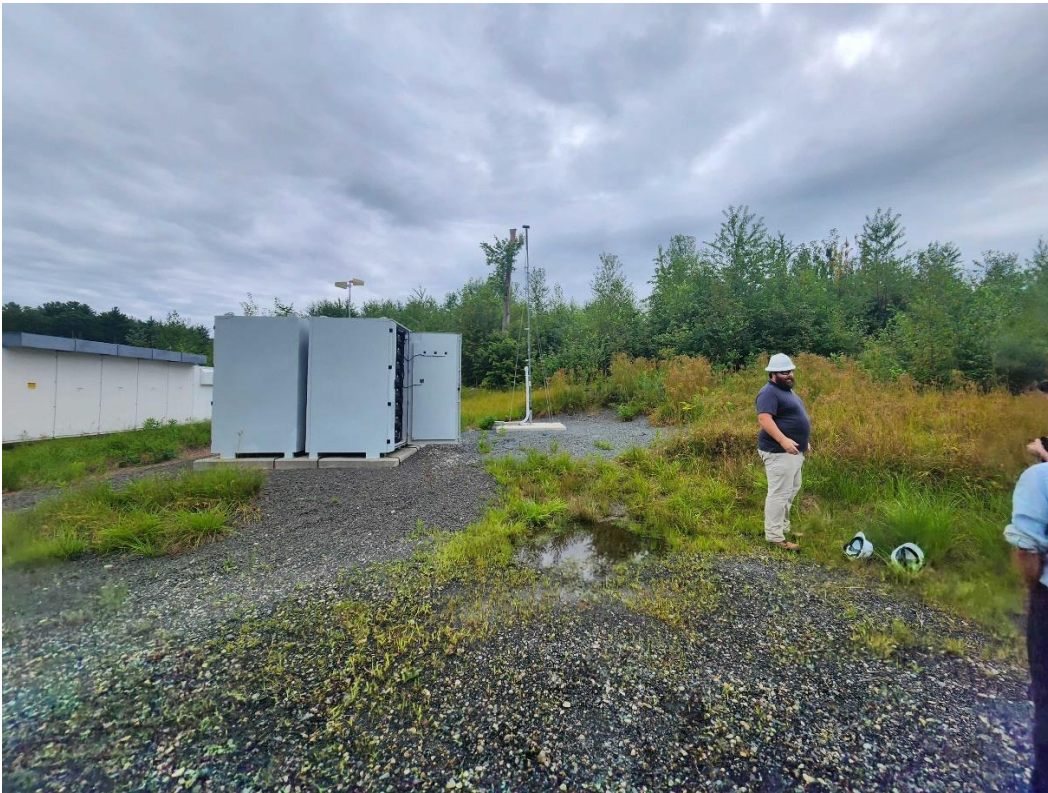
Siefert noted shallow water flowing from east to west over the service road, suggesting a culvert or other management action might be needed here.

Weston noted low vegetation growing near the battery pad and in close proximity of the re-vegetated "slope protection area" that runs in a NE direction through the facility. He expressed concern that lithium-ion battery fires are difficult to control and that in the event of a battery fire the nearby vegetation would likely catch fire and spread to the slope protection area and surrounding forest.

Location 5 (looking east). Northern lithium-ion battery pad showing the proximity of low vegetation to the battery cabinets and taller woody vegetation in the slope protection area in the background.

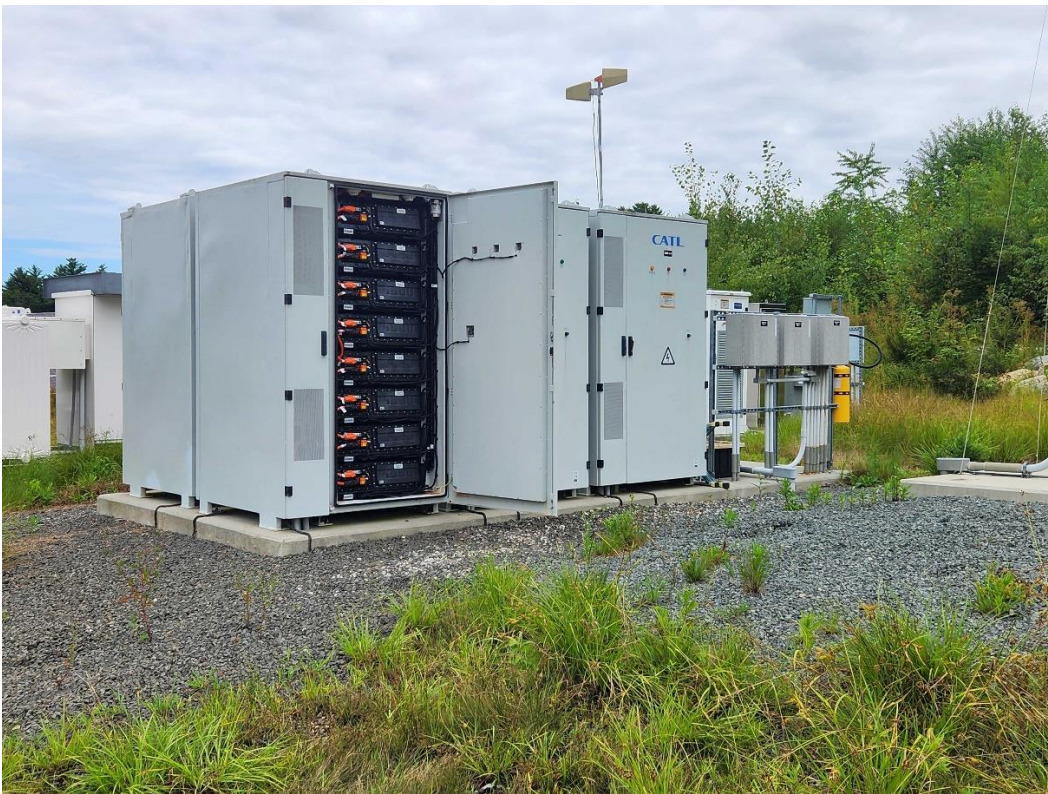
Location 5. Inside of a lithium-ion battery cabinet showing eight individual battery modules.

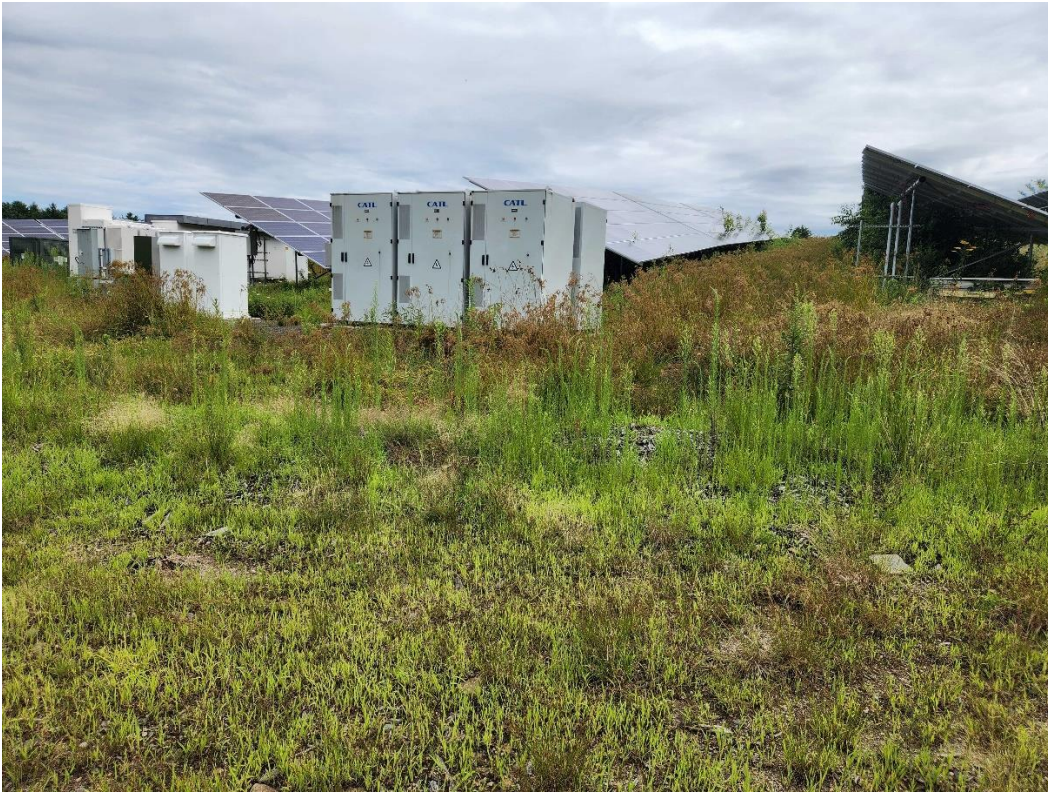
Weston again pointed out the potential for a battery fire to spread to the nearby vegetation and surrounding forest.

Location 6 (looking east). Southern lithium-ion battery pad showing the proximity of low vegetation around the battery cabinets.

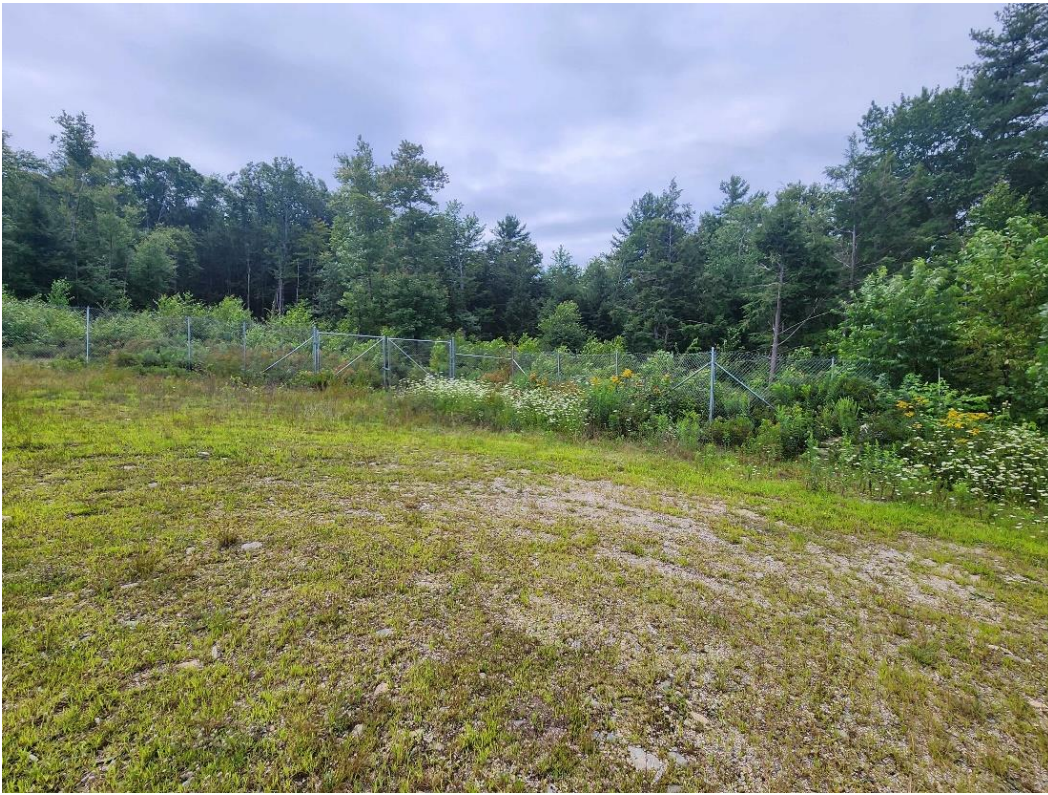
Siefert noted a pile of scrap wood and other debris along the perimeter fence.

Location 6 (looking to the southwest). End of the service drive and back gate. Wood and other debris was observed in the vegetation on the right side of the photo.

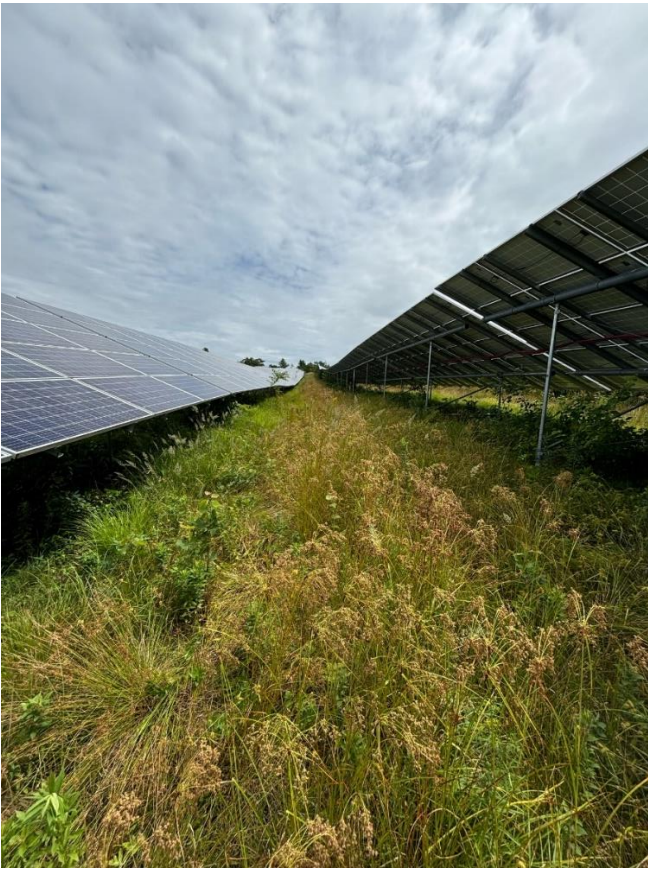
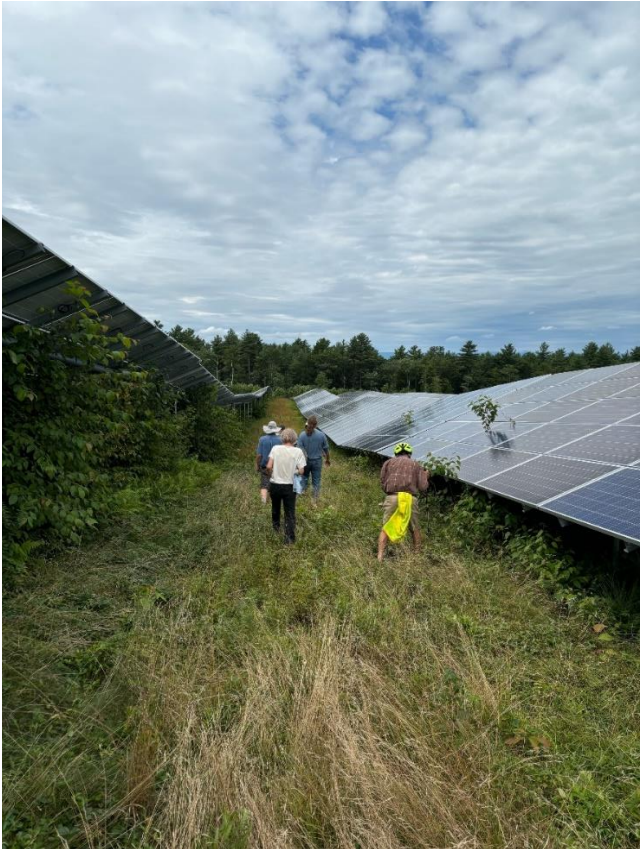
The group walked along the southern fence line to the southeast corner of the facility, continued north to the eighth row of solar arrays, then walked west between the eighth and ninth rows of arrays. The herbaceous vegetation appeared diverse and several areas between the arrays appeared to have wetland characteristics (eg. spongy ground, standing water).
