**Town of Shutesbury
Community Preservation Committee**

FY 2026 Application for Community Preservation Funding

Project Name: Rehabilitation of the front entry porch at the Spear Building

Applicant Organization: M.N. Spear Library Reuse Committee

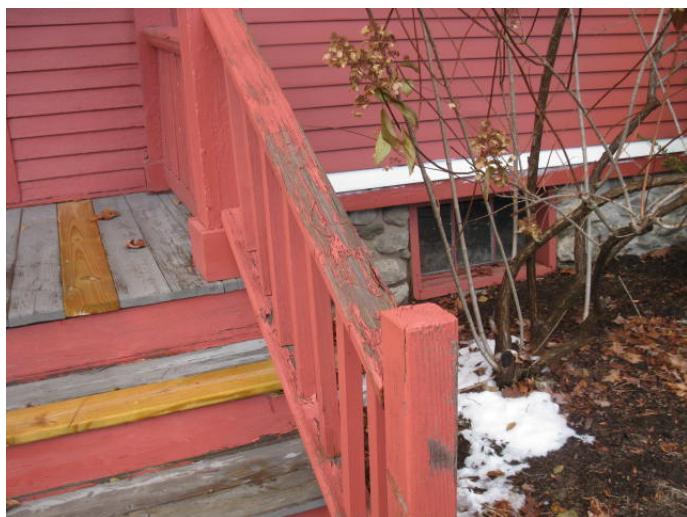
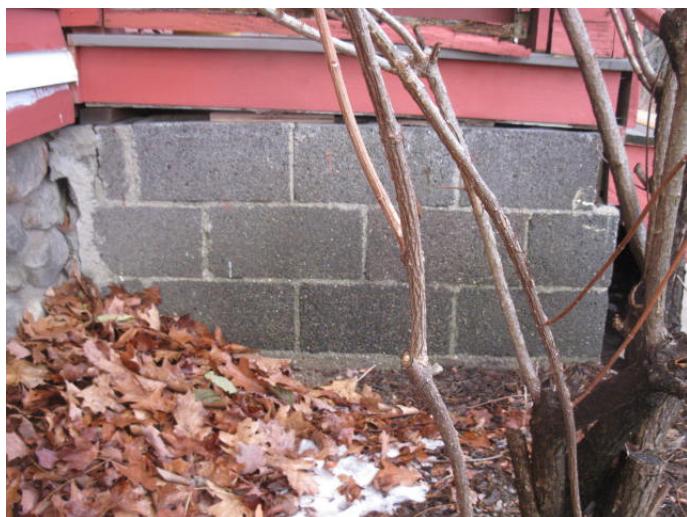
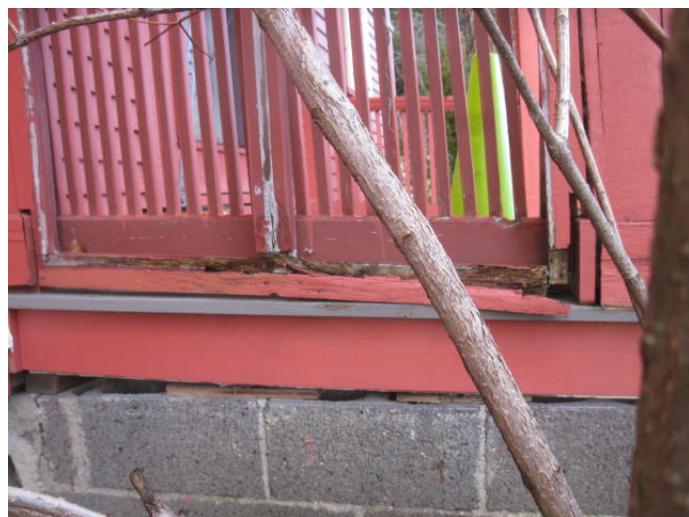
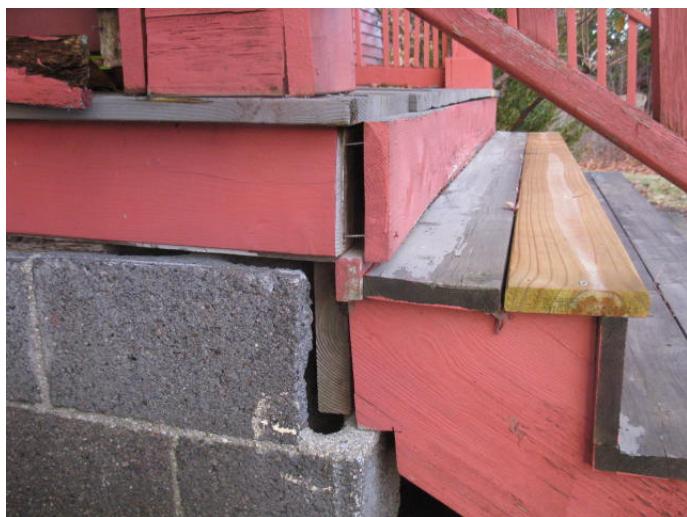
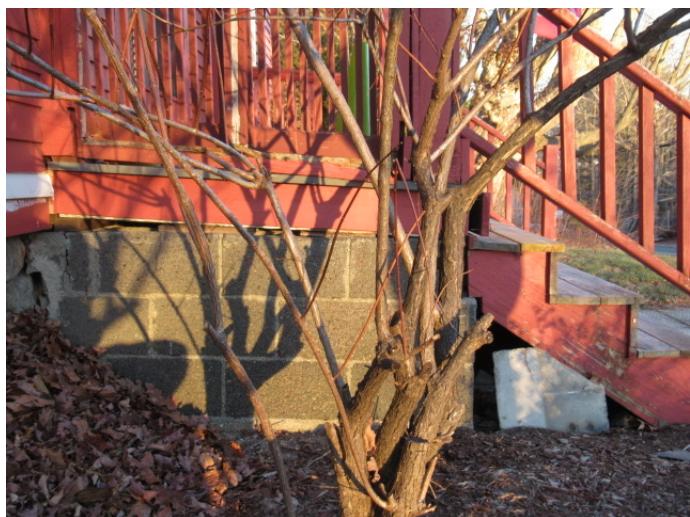
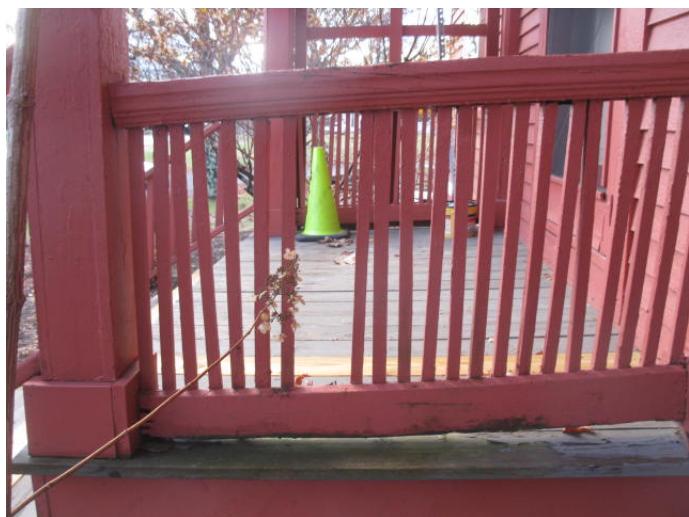
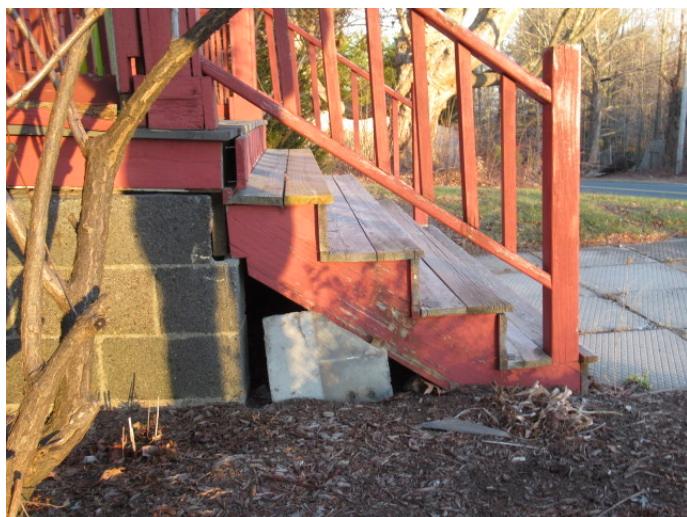
At the time of the inspection of the Spear photos were taken that show the existing conditions and concerns; e.g., the settlement of the ridge of the porch, the concrete block walls, signs of additonal settlement, rot/decay of components and lack of grippable handrails. (see photos)

Inspection of the M.N. Spear Library by the Buildings Committee in 2022 documented the settlement, likely ongoing, of the front entry porch of the library and the past inadequate attempts to stabilize the porch. This project will include significant structural renovations (removal of the previously installed but inadequate concrete block walls, temporary bracing of the roof structure, possible jacking to level the ridge of the roof, installing proper footings and reconstructing the floor structure and stairs) and the repair or replacement of historic details. Work to be done in a manner that meets the U.S. Department of Interior's Standards for Rehabilitation. Lead paint abatement will likely need to be done.

Success will be measured by the installation of proper footings to stabilize the entry porch and the reconstruction of the floor and stair structure. And by the repair of historic details e.g., the dental molding on the gable and the rails on each side of the porch, which will be raised to meet current code for safety, and detailed in a manner consistent with the existing details.
